Manhole Inspection Summary

Manhole # S21MM_003MH

Insp Date: **3/11/09 11:02 AM**

Location Address: **1571 RICHLAND ST**

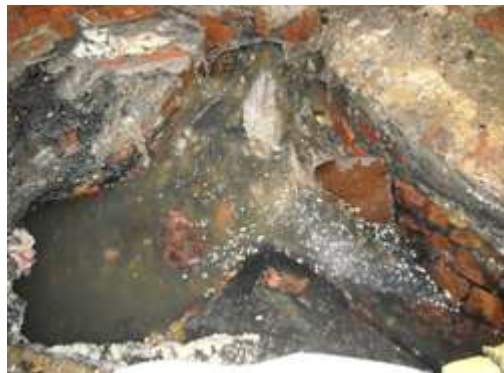
Top View

JUNCTION OFFSET MAKES TOP VIEW SHOWING ALL PIPE CONNECTIONS IMPOSSIBLE - DEBRIS IN CHANNEL -

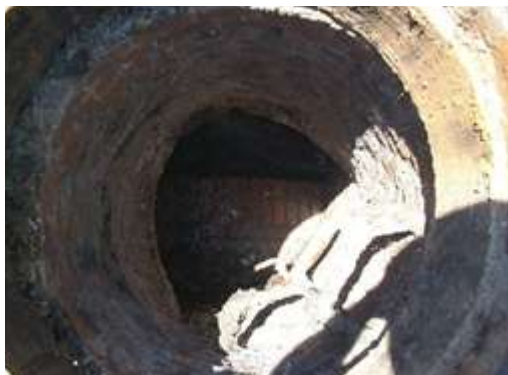
Top View

CORRODED STEPS

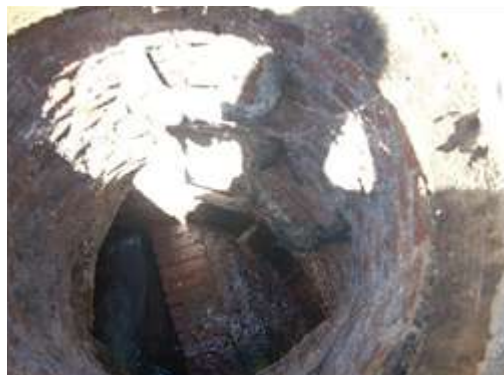
Defect 2

Steps Count: **5** Missing: **0** ☒ **Corroded**

CORRODED STEPS

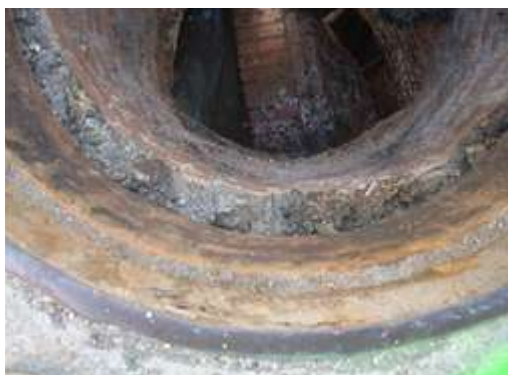
Defect 1

Frame Offset: **2** (in.) Condition: ☒ Sound ☐ Cracked ☐ Leaks

FRAME OFFSET

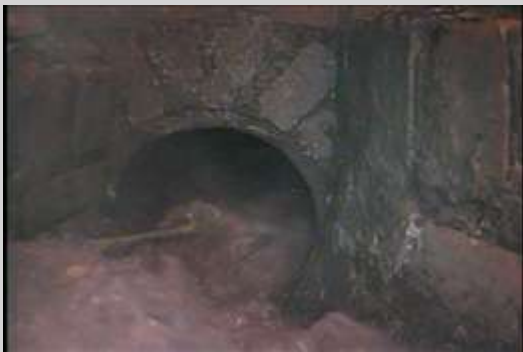
12 O'Clock Outflow

Pipe Height: **8.4** (in.) Rod and Bar (Angled)
Pipe Material: **Clay** ☐ Pipe Lined
Invert Depth: **8.29** (ft.) Flow Characteristics: **Slow**
Deposits: ☐ None ☐ Mud ☐ Sludge ☒ **Debris** ☐ Grease
Silt Depth: **2** (in.) Deposits Extent: **Light**
Infiltration: **None** Pipe Seal Cond: **Sound**

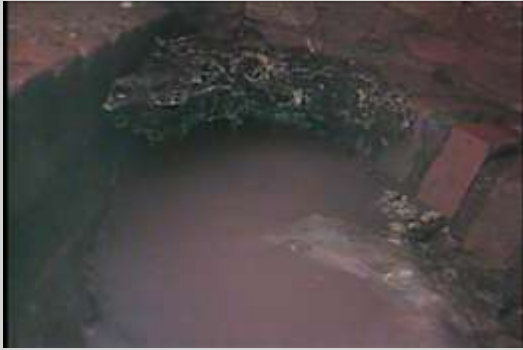
9 O'Clock Inflow

Deposits: ☐ None ☐ Mud ☐ Sludge ☒ **Debris** ☐ Grease

Silt Depth: **2** (in.) Deposits Extent: **Light**
